# Structural assessment of iron tie rods based on numerical modelling and experimental observations in Milan Cathedral

Grigor Angjeliu<sup>a,\*</sup>, Dario Coronelli<sup>a</sup>, Giuliana Cardani<sup>a</sup>, Thomas Boothby<sup>b</sup>

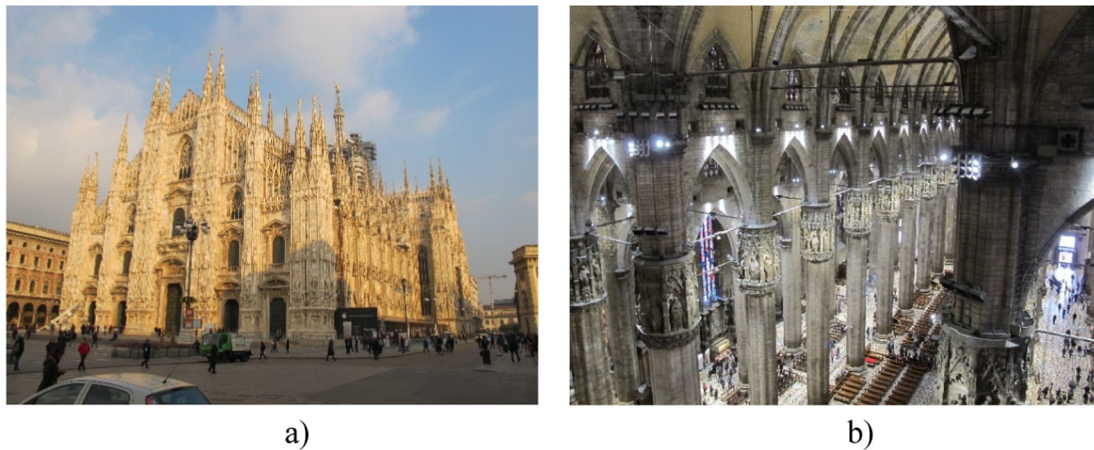
**Fig. 3.1.** Milan Cathedral: (a) South-West view of Milan Cathedral, (b) Iron tie rods inside the church.

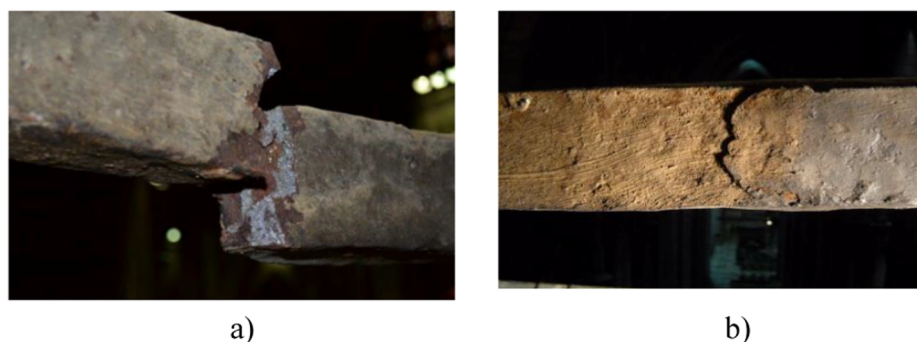
The presence of the tensile force in the ties results clearly from its position as well as from the observed failures. Recently, two failures were recorded in the nave ties of the 6th bay (2009), and 3rd bay (2011), arousing great concern about the statics and the safety of the cathedral (Fig. 3.6, – see also Fig. 3.7c).

Fig. 3.6. Documentation of iron tie failures: (a) Failure of the iron tie (6th bay T 2-3) [12], (b) Crack in the iron tie (3rd bay, T 2-3) [12].
